PAULINS KILL DAM

NJ 00274

PHASE 1 INSPECTION REPORT^C NATIONAL DAM SAFETY PROGRAM

PAULINS KILL DAM (NJ00274)

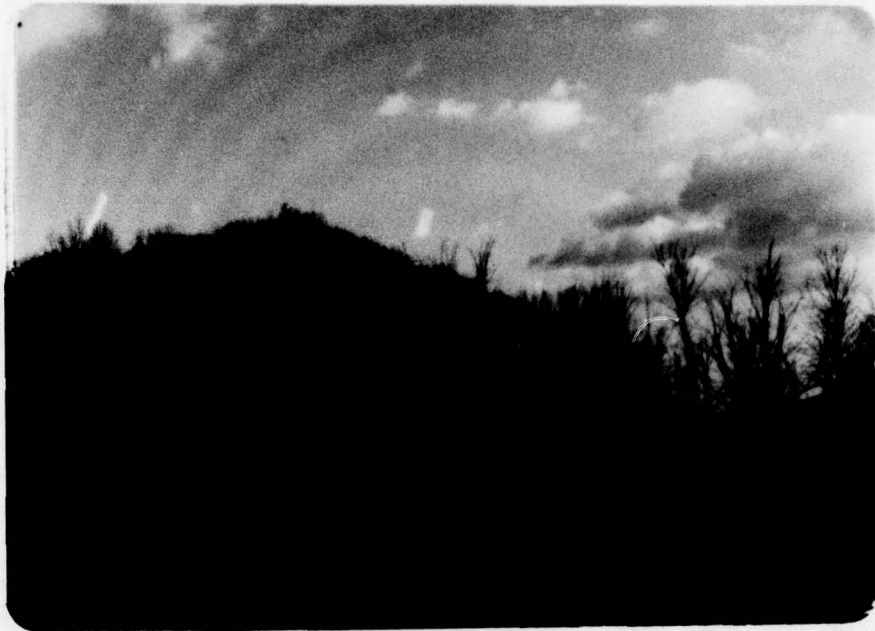
Right abutment and spillway.
Looking upstream

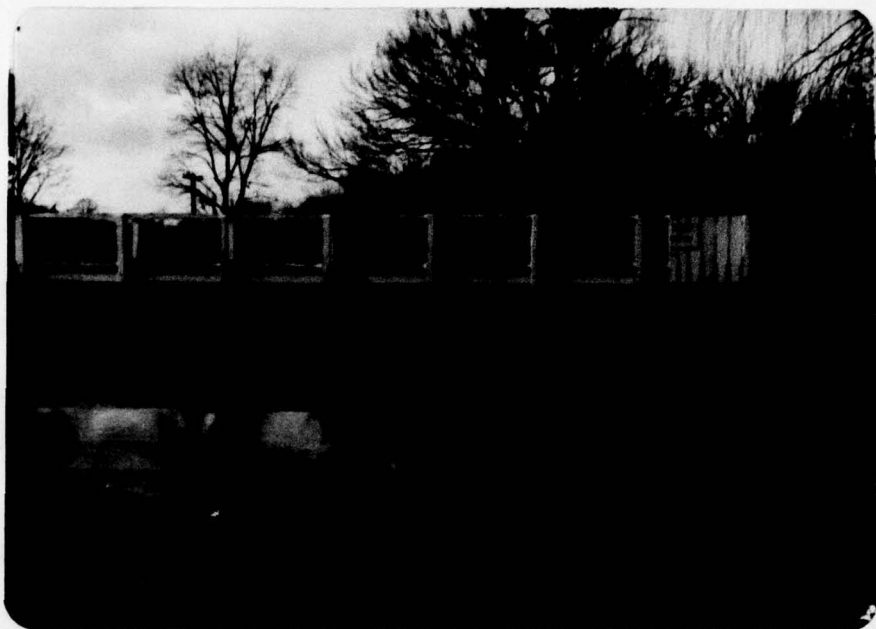
Footbridge and low level gate operator stand at left side of photo. 21 December 1978

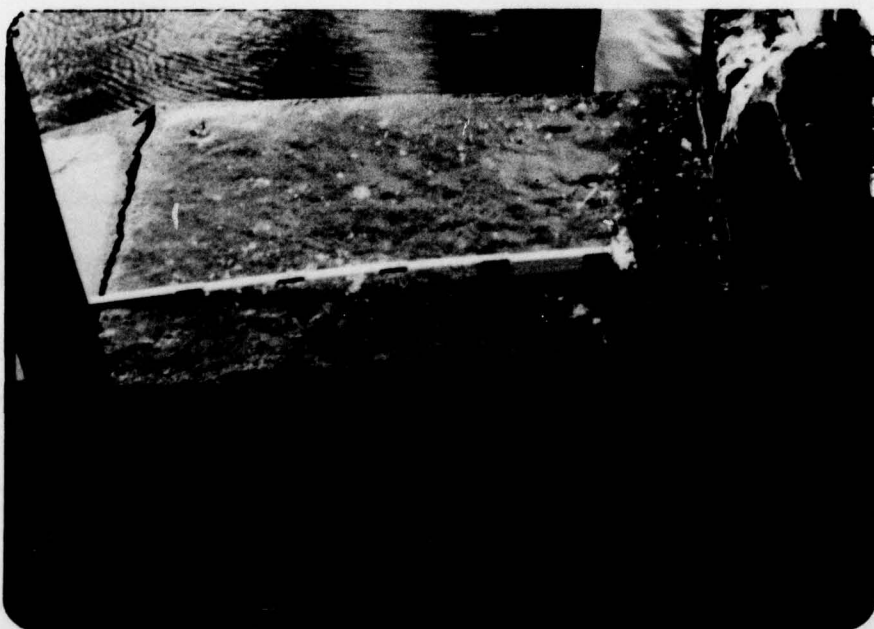
Cracks in right side wall of spillway.

7. The cracked spillway right side wall should be repaired and if necessary strengthened. This should be done soon.
8. All trees should be removed from the area of the dam. This should be done soon.

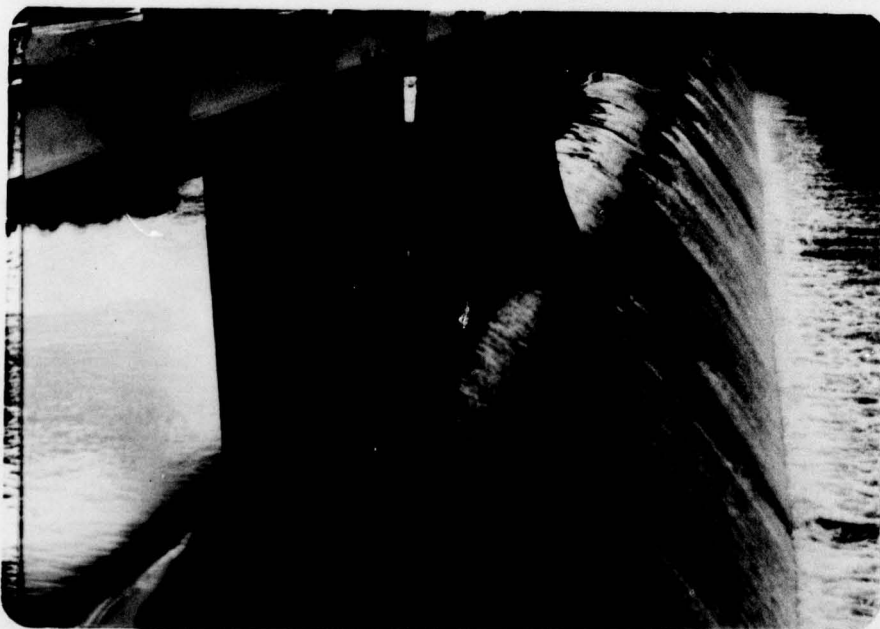
Piers supporting footbridge. Concrete spalled downstream. Note water level gage on pier. Looking right to left.

5. Spalled and deteriorated concrete should be repaired. This should be done soon.
6. Erosion at the junction of the spillway side walls and embankment should be suitably backfilled and protected against further erosion. This should be done soon.

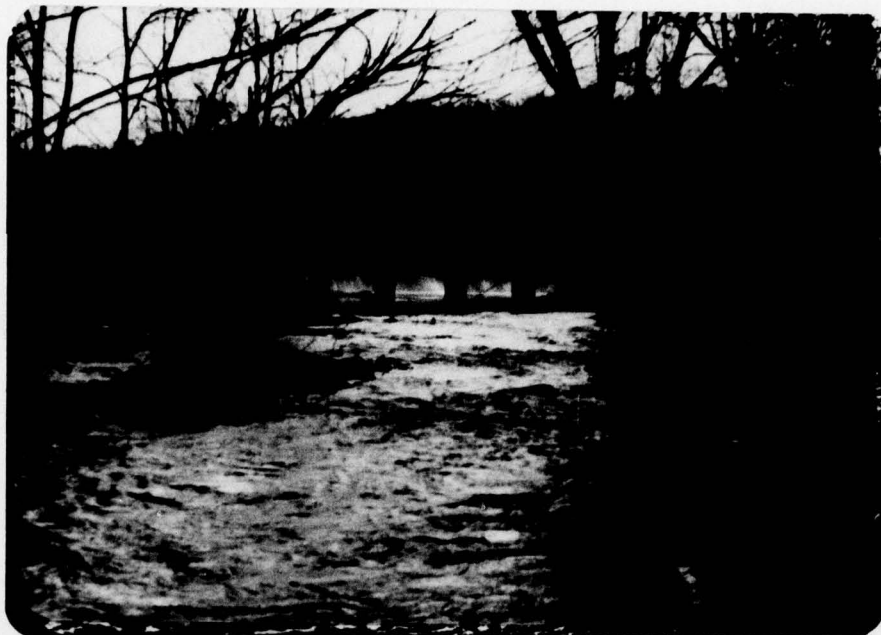
Spillway, Paulins Kill Road Bridge and downstream channel. Looking upstream.

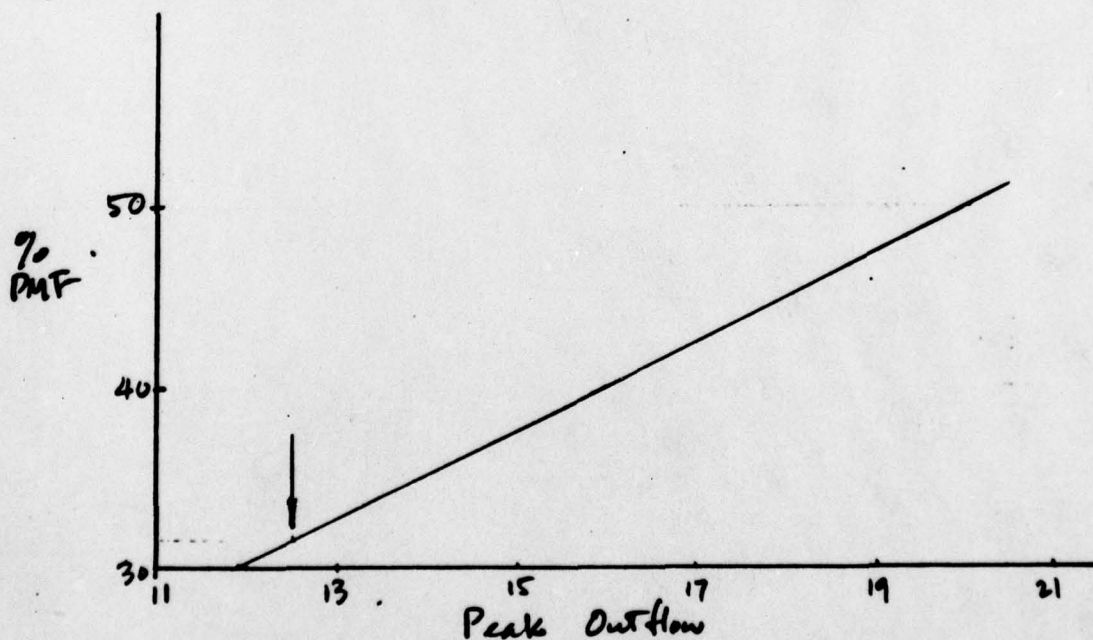
OVERTOPPING POTENTIAL

3. Dam overtops at approx. El. 461.7 with $Q = 12580$ cfs
 \therefore dam can pass approx. 32 % of PMF.
